Great Bradley Church Bells.

Items Requiring Attention at 16 May 1981

INSPECTION OF BELLS

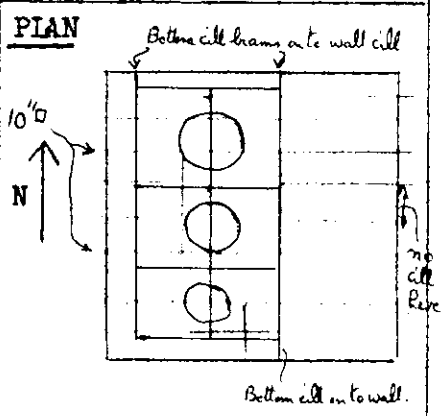
Type.	
	Age. mediaeval?	
	Signs of Decay? Some	
	Traces of Beetle? Yes	Type? Death watch
	Type of Bearings. None	
	Level of <del>chime</del> <sup>cill</sup> . 1' 8" Above <del>floor</del> Windowsill.	
	How Supported? see below	
	Clamped with Metal? in odd places	
	Wheels. None	
Stays. None		
Sliders. None		
Ground Pulleys. Good where fitted, 1935		
Floor. Fragmentary		
Frame Beams. In fair state, adequate for bells of this weight not swung. The frame is set on 2 E-W beams set into tower walls at their ends, the W ends rest on wall cill. The E ends are not easy to inspect but as two of the beams are 10" square they should be stout enough even with a little decay in the E wall. To check these ends the floor boards here should be lifted.
